**Flood Control Project Maintenance  
Levee Inspections**

## Maintenance Issue Types Only, Levee Inspection Report By Mile - Spring 2018

### Reclamation District No. 1001 Nicolaus

Waterway	Bank	Unit Miles	Inspection Start/End	Inspector
Unit No. 01 Yankee Slough	Right	4.12	04/03/2018 04/03/2018	Sterling York

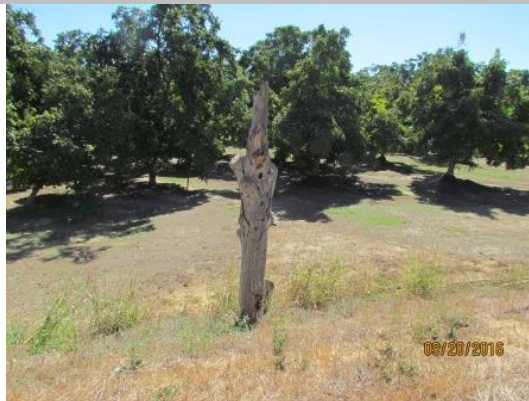
Photo 1 of 1 : SP\_2018\_RD1001\_35\_6\_20180302\_00002.jpg

LM Start	1.88	Rating **	N	Issue No.	6
LM End	1.88	Issue Type +	Ma	Location *	LS
Category	Earthen Levee			GPS Latitude/Longitude	
				Start	End
Item	Trim / Thin Trees			38.969489 °	38.969489 °
				-121.504155 °	-121.504155 °
DWR ID	DWR_RD1001_02_f_2015_6				
Comment Code					
T5 : Tree stumps.					
Inspector Comment					
Large stump at the landside levee toe should be removed, Fall 2017.

View of large stump at the landside levee toe. Fall 2016.

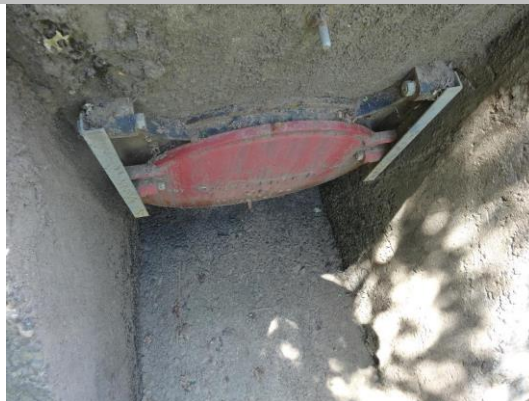
Photo 2 of 3 : UCIP\_SP\_2018\_14008\_23107.jpg

WS- outfall pipe with flap gate in concrete wing wall.

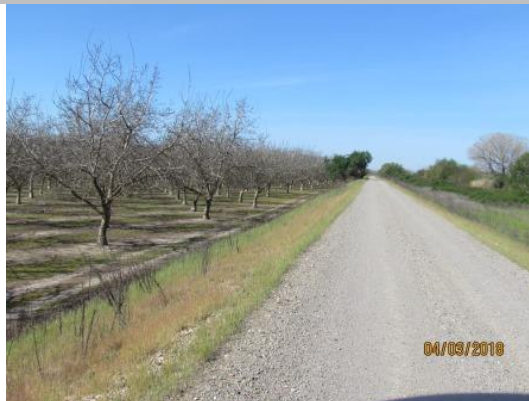
Photo 1 of 1 : SP\_2018\_RD1001\_37\_13\_20180409\_00054.jpg

LM Start	0.00	Rating **	A	Issue No.	13
LM End	12.58	Issue Type +	Ma	Location *	LS
Category	Earthen Levee			GPS Latitude/Longitude	
				Start	End
Item	Vegetation			39.006478 °	38.941103 °
				-121.375035 °	-121.567605 °
DWR ID	DWR_RD1001_03_s_2018_13				
Comment Code					
V1 : Control annual grass and weeds on the levee slopes and easements.					
Inspector Comment					
Annual vegetation is well maintained, Spring 2018.

View looking downstream landside of the well maintained annual vegetation, Spring 2018.

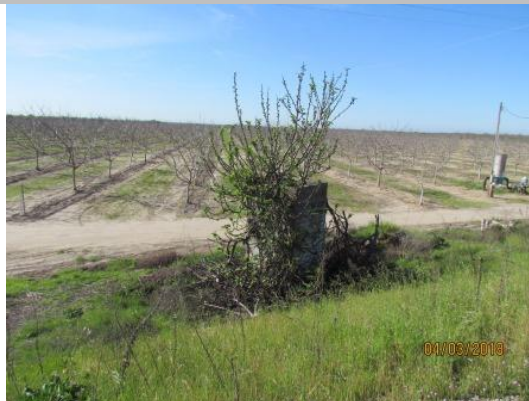
Photo 1 of 1 : SP\_2018\_RD1001\_37\_36\_20180409\_00061.jpg

LM Start	2.59	Rating **	A/W	Issue No.	36
LM End	2.59	Issue Type +	Ma	Location *	LS
Category	Earthen Levee			GPS Latitude/Longitude	
				Start	End
Item	Trim / Thin Trees			38.995583 °	38.995583 °
				-121.417995 °	-121.417995 °
DWR ID	DWR_RD1001_03_s_2015_36				
Comment Code					
T3 : Trim and thin trees to allow visibility of the ground and room to flood fight.					
Inspector Comment					
Tree less than 4" in diameter should be removed, Spring 2018.

View of a small starter tree on landside slope looking downstream that is less than 4" in diameter, Spring 2018.

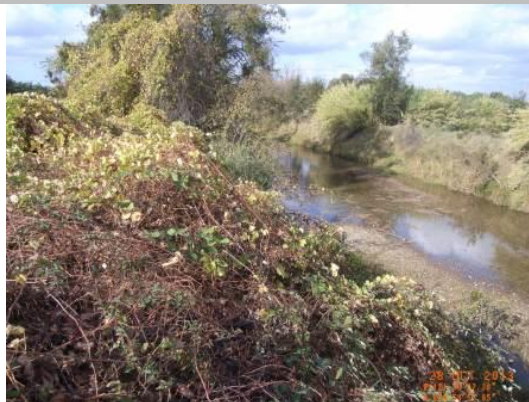
Photo 1 of 1 : SP\_2018\_RD1001\_37\_17\_20180302\_00017.jpg

LM Start	7.22	Rating **	M	Issue No.	17
LM End	7.31	Issue Type +	Ma	Location *	WS
Category	Supplemental			GPS Latitude/Longitude	
				Start	End
Item	2015 USACE Erosion Survey, DRAFT			38.982737 °	38.982572 °
				-121.501144 °	-121.502797 °
DWR ID	DWR_RD1001_03_s_2016_17				
Comment Code					
Inspector Comment					
2008 - Sandy/silty banks with rotational slab failures creating near vertical bank with pop-outs due to tree failures. Narrow berm. 2015: Last observed in 2013. [2015 Site ID: BER_5-7_L]

USACE 2013 Photo #1

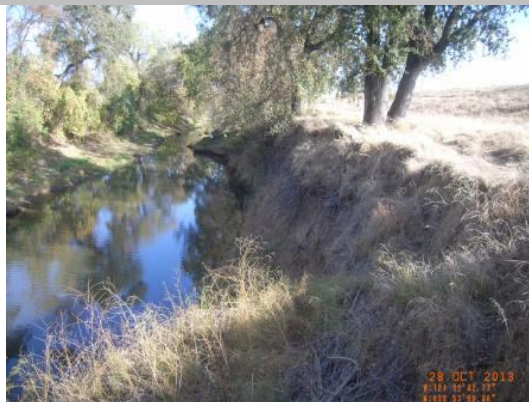
Photo 1 of 1 : SP\_2018\_RD1001\_37\_10\_20180302\_00011.jpg

LM Start	10.36	Rating **	M	Issue No.	10
LM End	10.40	Issue Type +	Ma	Location *	WS
Category	Supplemental			GPS Latitude/Longitude	
				Start	End
Item	2015 USACE Erosion Survey, DRAFT			38.964583 °	38.964010 °
				-121.544967 °	-121.545228 °
DWR ID	DWR_RD1001_03_s_2016_10				
Comment Code					
Inspector Comment					
2011 - Large section of bank has slumped off. RD has flagged and appears to be watching. 2012 - Slopes slightly steeper. 2013 - Minor new erosion observed. 2015: Last observed in 2013. [2015 Site ID: BER_2-5_L]

USACE 2013 Photo #1

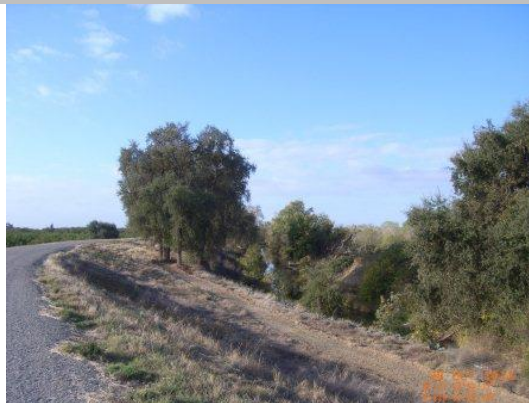
Photo 1 of 1 : SP\_2018\_RD1001\_37\_1\_20180302\_00001.jpg

LM Start	11.08	Rating **	A/W	Issue No.	1
LM End	11.16	Issue Type +	Ma	Location *	WS
Category	Supplemental			GPS Latitude/Longitude	
				Start	End
Item	2015 USACE Erosion Survey, DRAFT			38.955070 °	38.954227 °
				-121.549528 °	-121.550592 °
DWR ID	DWR_RD1001_03_s_2016_1				
Comment Code					
Inspector Comment					
2011 - Large slumped sections of bank. 2012 - Slopes slightly steeper. 2015: Last observed in 2013. [2015 Site ID: BER_1-9_L]

USACE 2013 Photo #1

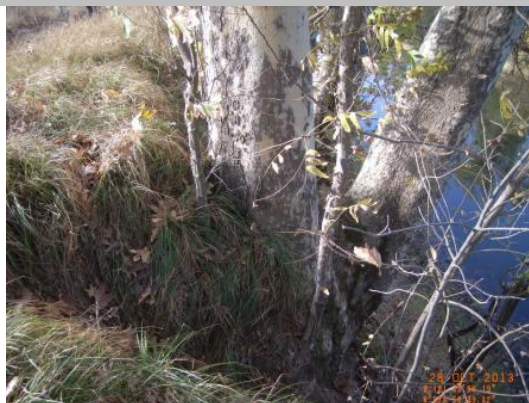
Photo 1 of 1 : SP\_2018\_RD1001\_37\_4\_20180302\_00005.jpg

LM Start	12.07	Rating **	A/W	Issue No.	4
LM End	12.16	Issue Type +	Ma	Location *	WS
Category	Supplemental			GPS Latitude/Longitude	
				Start	End
Item	2015 USACE Erosion Survey, DRAFT			38.947591 °	38.946477 °
				-121.563390 °	-121.564094 °
DWR ID	DWR_RD1001_03_s_2016_4				
Comment Code					
Inspector Comment					
2006 - Multiple rotational failures in the berm. Erosion is into the levee toe and lower slope. Tension cracks extensive at top of bank. Cohesive toe creates a bench on which failures occur. 2007 - Still steep bank with some berm with pistol-butted reeds. 2012 - Site extended upstream due to additional slumping. Slopes slightly steeper. 2015: Last observed in 2013. [2015 Site ID: BER_0-8_L]

USACE 2013 Photo #1

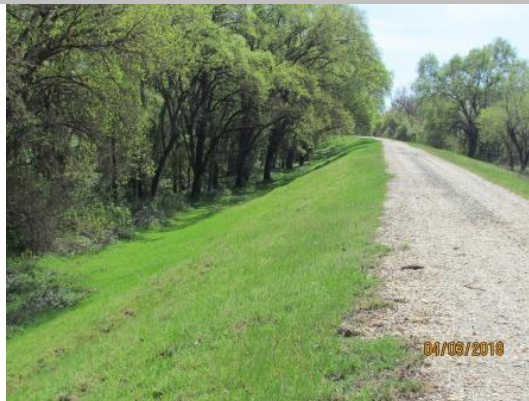
Photo 1 of 1 : SP\_2018\_RD1001\_38\_55\_20180411\_00083.jpg

LM Start	0.04	Rating **	A	Issue No.	55
LM End	13.26	Issue Type +	Ma	Location *	LS
Category	Earthen Levee			GPS Latitude/Longitude	
				Start	End
Item	Vegetation			38.940543 °	38.781191 °
				-121.567800 °	-121.605619 °
DWR ID	DWR_RD1001_04_f_2017_55				
Comment Code					
V1 : Control annual grass and weeds on the levee slopes and easements.					
Inspector Comment					
Annual vegetation is well maintained, Spring 2018.

View looking downstream landside of the well maintained annual vegetation, Spring 2018.

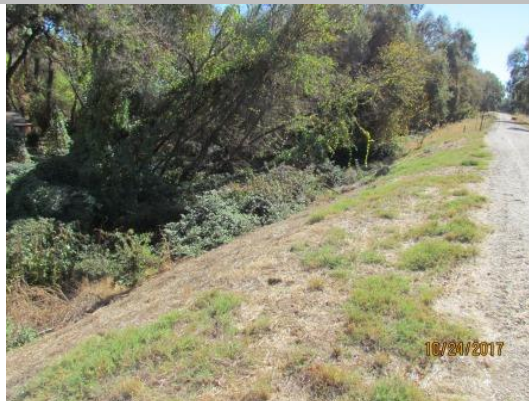
Photo 1 of 1 : SP\_2018\_RD1001\_38\_57\_20180302\_00043.jpg

LM Start	0.13	Rating **	M	Issue No.	57
LM End	0.13	Issue Type +	Ma	Location *	LS
Category	Earthen Levee			GPS Latitude/Longitude	
				Start	End
Item	Vegetation			38.939219 °	38.939219 °
				-121.567789 °	-121.567789 °
DWR ID	DWR_RD1001_04_f_2017_57				
Comment Code					
V2 : Remove the wild growth other than native grasses from the levee slopes.					
Inspector Comment					
Remove wild growth from levee slope, Fall 2017.

View looking downstream landside of wild growth that is creeping up the levee slope, Fall 2017.

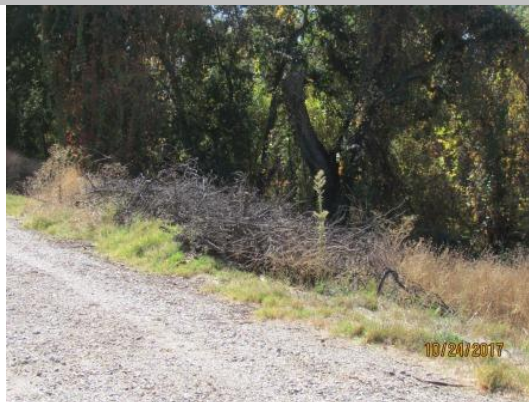
Photo 1 of 1 : SP\_2018\_RD1001\_38\_3\_20180302\_00003.jpg

LM Start	0.14	Rating **	M	Issue No.	3
LM End	0.14	Issue Type +	Ma	Location *	WS
Category	Earthen Levee			GPS Latitude/Longitude	
				Start	End
Item	Encroachments			38.939029 °	38.939029 °
				-121.567771 °	-121.567771 °
DWR ID	DWR_RD1001_04_s_2017_3				
Comment Code					
PR : Prunings					
Inspector Comment					
Remove pruning's from hinge point, Fall 2017.

View looking downstream of pruning's on hinge point, Fall 2017.

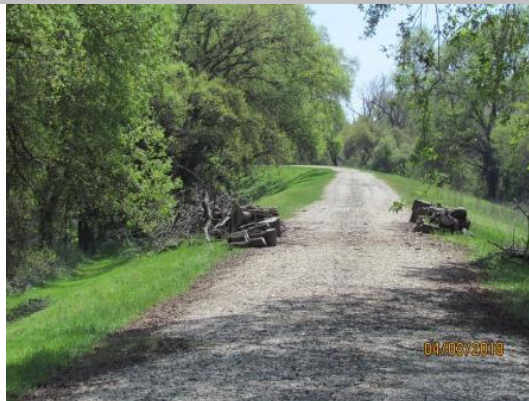
Photo 1 of 2 : SP\_2018\_RD1001\_38\_42\_20180411\_00089.jpg

LM Start	0.20	Rating **	M	Issue No.	42
LM End	0.20	Issue Type +	Ma	Location *	CR
Category	Earthen Levee			GPS Latitude/Longitude	
				Start	End
Item	Encroachments			38.938233 °	38.938233 °
				-121.567731 °	-121.567731 °
DWR ID	DWR_RD1001_04_s_2017_42				
Comment Code					
PR : Prunings					
Inspector Comment					
Remove pruning's from fallen tree from both sides of hinge points, Spring 2017.

View looking downstream of pruning's from fallen tree on both sides of hinge points, Spring 2018.

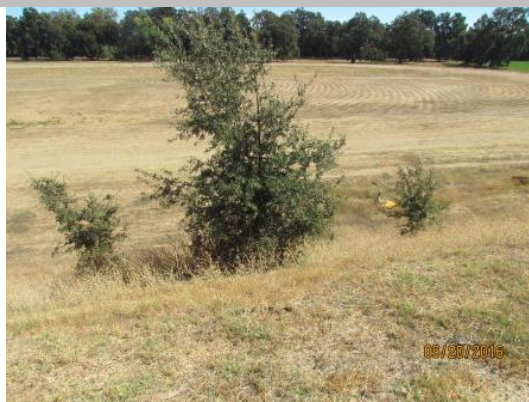
Photo 1 of 1 : SP\_2018\_RD1001\_38\_59\_20180302\_00045.jpg

LM Start	0.49	Rating **	M	Issue No.	59
LM End	0.49	Issue Type +	Ma	Location *	LS
Category	Earthen Levee			GPS Latitude/Longitude	
				Start	End
Item	Trim / Thin Trees			38.934139 °	38.934139 °
				-121.567025 °	-121.567025 °
DWR ID	DWR_RD1001_04_f_2016_59				
Comment Code					
T2 : Thin trees to allow visibility of the ground and room to flood fight.					
Inspector Comment					
Trees 4" in diameter or less at chest height should be removed.

View of three trees with diameters less than 4". Fall 2016.

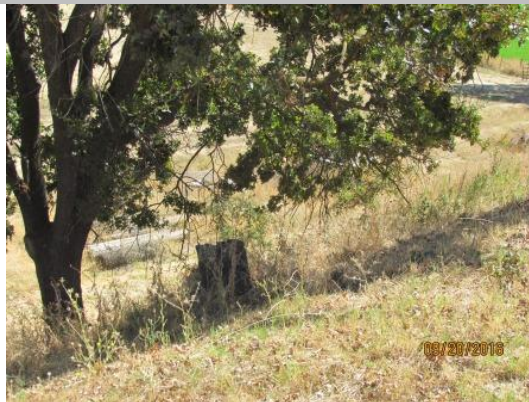
Photo 1 of 1 : SP\_2018\_RD1001\_38\_21\_20180302\_00013.jpg

LM Start	0.51	Rating **	N	Issue No.	21
LM End	0.51	Issue Type +	Ma	Location *	LS
Category	Earthen Levee			GPS Latitude/Longitude	
				Start	End
Item	Trim / Thin Trees			38.933796 °	38.933796 °
				-121.567047 °	-121.567047 °
DWR ID	DWR_RD1001_04_f_2015_21				
Comment Code					
T5 : Tree stumps.					
Inspector Comment					
Remove stump from the landside levee slope.

View of a stump in the landside levee slope. Fall 2016.

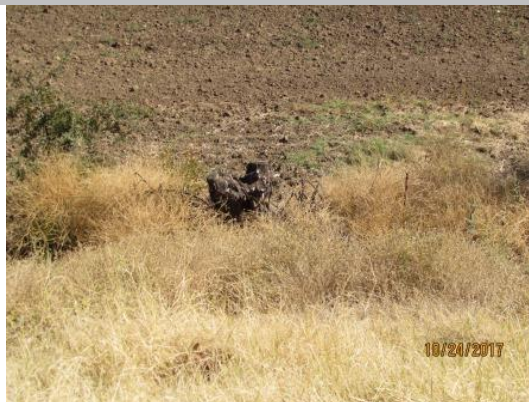
Photo 1 of 1 : SP\_2018\_RD1001\_38\_69\_20180302\_00057.jpg

LM Start	1.06	Rating **	N	Issue No.	69
LM End	1.06	Issue Type +	Ma	Location *	LS
Category	Earthen Levee			GPS Latitude/Longitude	
				Start	End
Item	Trim / Thin Trees			38.926128 °	38.926128 °
				-121.568241 °	-121.568241 °
DWR ID	DWR_RD1001_04_s_2016_69				
Comment Code					
T5 : Tree stumps.					
Inspector Comment

View of landside toe of a stump that needs to be removed, Fall 2017.

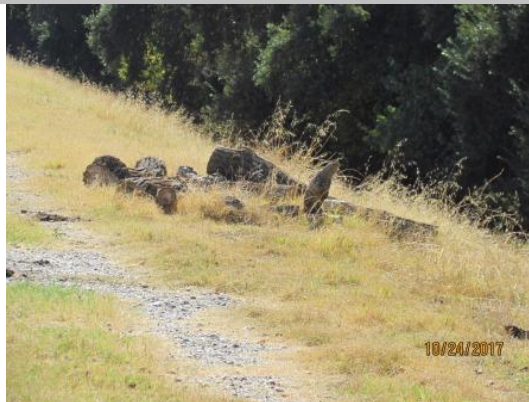
Photo 1 of 2 : SP\_2018\_RD1001\_38\_65\_20180302\_00052.jpg

LM Start	1.07	Rating **	M	Issue No.	65
LM End	1.07	Issue Type +	Ma	Location *	CR
Category	Earthen Levee			GPS Latitude/Longitude	
				Start	End
Item	Encroachments			38.925991 °	38.925991 °
				-121.568282 °	-121.568282 °
DWR ID	DWR_RD1001_04_f_2017_65				
Comment Code					
FW : Firewood					
Inspector Comment					
Remove firewood from levee crown, Spring 2018.

View looking downstream waterside crown at firewood, Fall 2017.

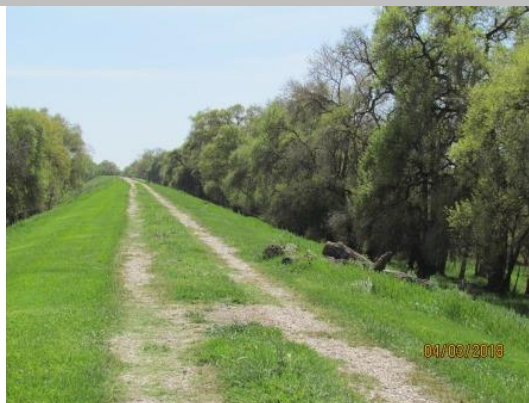
Photo 2 of 2 : SP\_2018\_RD1001\_38\_65\_20180411\_00091.jpg

LM Start	1.07	Rating **	M	Issue No.	65 (cont)	
LM End	1.07	Issue Type +	Ma	Location *	CR	
Category	Earthen Levee			GPS Latitude/Longitude		
				Start		End
Item	Encroachments			38.925991 °	38.925991 °	
				-121.568282 °	-121.568282 °	
DWR ID	DWR_RD1001_04_f_2017_65					
Comment Code						
FW : Firewood						
Inspector Comment						
Remove firewood from levee crown, Spring 2018.

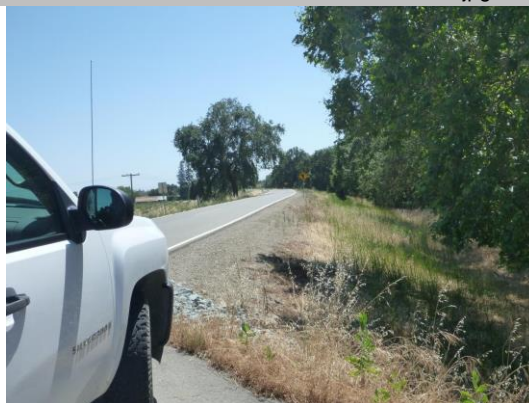
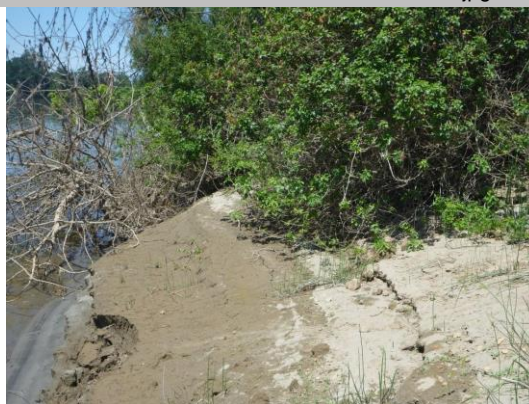
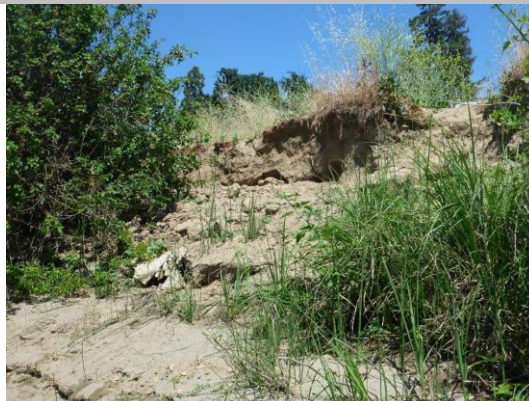
LM Start	5.61	Rating **	A/W	Issue No.	35 (cont)	
LM End		Issue Type +	Ma	Location *	WS	
Category	Supplemental			GPS Latitude/Longitude		
				Start	End	
Item	2017 Storm Damage			38.876374 °		°
				-121.613425 °		°
DWR ID	DWR_RD1001_04_f_2017_35					
Comment Code						
Inspector Comment						
Levee Evaluation Comments						
Description:						
Site ID No:139						
Site Designation:LMA-19						
Repair Type: Erosion						
Rating:Area of Concern						
Field Date:6/6/2017						
Notes: Several small erosion sites along 2 miles.

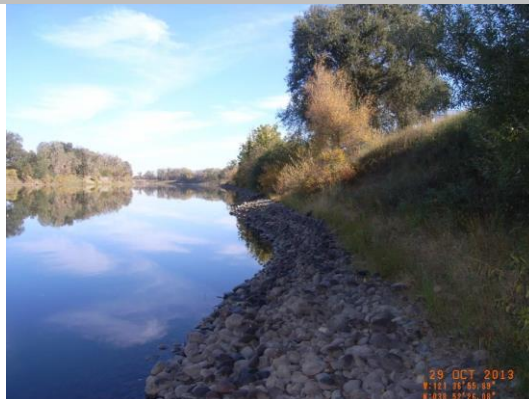
Photo 1 of 1 : SP\_2018\_RD1001\_38\_2\_20180302\_00002.jpg

LM Start	5.80	Rating **	M	Issue No.	2
LM End	5.93	Issue Type +	Ma	Location *	WS
Category	Supplemental			GPS Latitude/Longitude	
				Start	End
Item	2015 USACE Erosion Survey, DRAFT			38.874113 °	38.872373 °
				-121.615380 °	-121.616504 °
DWR ID	DWR_RD1001_04_s_2016_2				
Comment Code					
Inspector Comment					
2011 - Erosion pockets from tree popouts. Sections of the lower bank have slumped off. 2013 - Scallops from tree popouts no longer visible on site. Minor new erosion at the middle of the bank. 2015: Fresh erosion from human use. [2015 Site ID: FHR_6-6_L]

USACE 2013 Photo #1

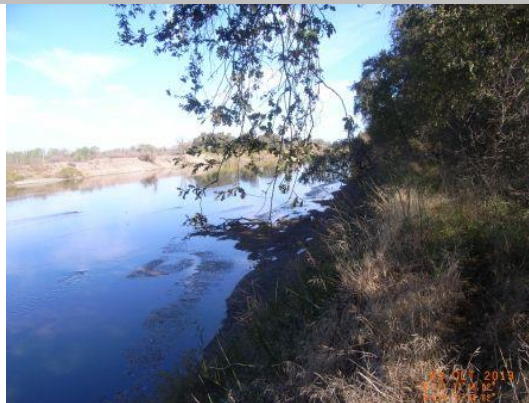
Photo 1 of 1 : SP\_2018\_RD1001\_38\_5\_20180302\_00005.jpg

LM Start	6.42	Rating **	M	Issue No.	5
LM End	6.51	Issue Type +	Ma	Location *	WS
Category	Supplemental			GPS Latitude/Longitude	
				Start	End
Item	2015 USACE Erosion Survey, DRAFT			38.865875 °	38.864706 °
				-121.619983 °	-121.620813 °
DWR ID	DWR_RD1001_04_s_2016_5				
Comment Code					
Inspector Comment					
2011 - Tall slumping sections. Scour around trees has exposed most of the roots. 2015: Recent large slope failure observed. [2015 Site ID: FHR_6-0_L]

USACE 2013 Photo #1

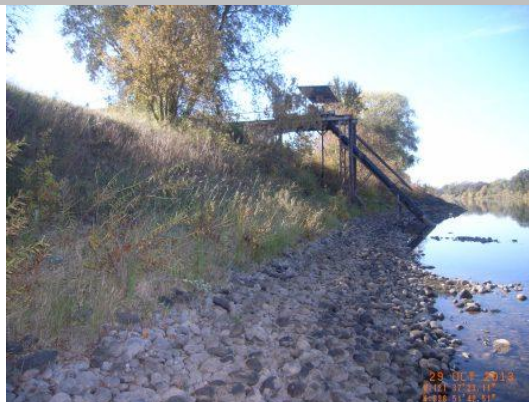
Photo 1 of 1 : SP\_2018\_RD1001\_38\_4\_20180302\_00004.jpg

LM Start	6.57	Rating **	M	Issue No.	4
LM End	6.77	Issue Type +	Ma	Location *	WS
Category	Supplemental			GPS Latitude/Longitude	
				Start	End
Item	2015 USACE Erosion Survey, DRAFT			38.863946 °	38.861558 °
				-121.621388 °	-121.623316 °
DWR ID	DWR_RD1001_04_s_2016_4				
Comment Code					
Inspector Comment					
2011 - Large slumped sections on the lower bank. 2012 - New cracks observed. 2015: No observed changes. [2015 Site ID: FHR_5-8_L]

USACE 2013 Photo #1

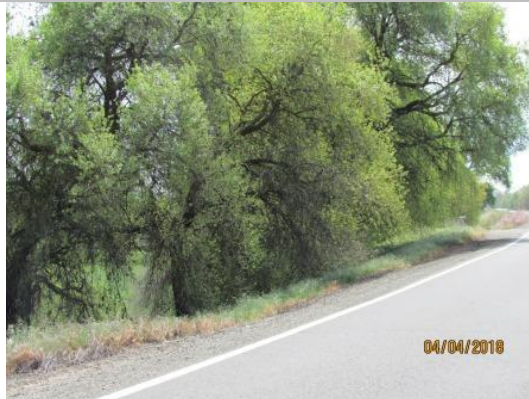
Photo 1 of 1 : SP\_2018\_RD1001\_38\_45\_20180411\_00098.jpg

LM Start	7.32	Rating **	M	Issue No.	45
LM End	7.32	Issue Type +	Ma	Location *	LS
Category	Earthen Levee			GPS Latitude/Longitude	
				Start	End
Item	Trim / Thin Trees			38.854324 °	38.854324 °
				-121.627970 °	-121.627970 °
DWR ID	DWR_RD1001_04_s_2018_45				
Comment Code					
T1 : Trim trees to at least five feet above ground level.					
Inspector Comment					
Trim limbs for access and visibility, Spring 2018.

View looking downstream landside of trees that need limbs trimmed for access and visibility, Spring 2018.

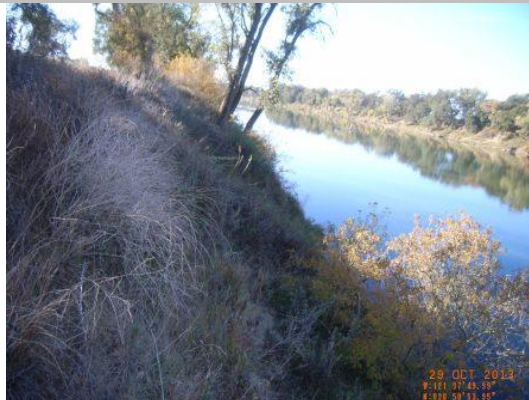
Photo 1 of 1 : SP\_2018\_RD1001\_38\_8\_20180302\_00008.jpg

LM Start	7.47	Rating **	M	Issue No.	8
LM End	7.79	Issue Type +	Ma	Location *	WS
Category	Supplemental			GPS Latitude/Longitude	
				Start	End
Item	2015 USACE Erosion Survey, DRAFT			38.852394 °	38.848004 °
				-121.629231 °	-121.630873 °
DWR ID	DWR_RD1001_04_s_2016_8				
Comment Code					
Inspector Comment					
2000 - Steep bank off berm with some slumps and fallen trees, continued erosion. 2002 - Site lengthened upstream and downstream due to vertical bank along most of the reach. 2010 - Site extended upstream. 2011 - Minimal new erosion. 2012 - Site extended on the upstream end, new tree pop-out, and bank erosion continues to worsen. 2013 - Minor new erosion at the toe and top of bank. 2015: No observed changes. [2015 Site ID: FHR_5-0_L]

USACE 2013 Photo #1

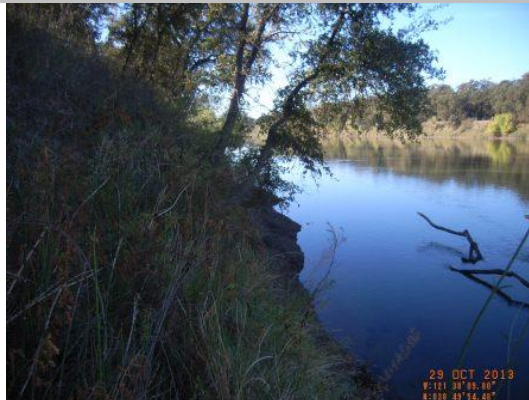
Photo 1 of 1 : SP\_2018\_RD1001\_38\_7\_20180302\_00007.jpg

LM Start	8.57	Rating **	M	Issue No.	7
LM End	8.97	Issue Type +	Ma	Location *	WS
Category	Supplemental			GPS Latitude/Longitude	
				Start	End
Item	2015 USACE Erosion Survey, DRAFT			38.836966 °	38.831498 °
				-121.634128 °	-121.636371 °
DWR ID	DWR_RD1001_04_s_2016_7				
Comment Code					
Inspector Comment					
2006 - Sandy, silty bank with intermittent pockets of erosion. Rotational failure and tree pop outs are most of the problem. Some upper slope fluvial erosion. 2010 - Site extended upstream. The lower Feather may benefit from a regional repair. 2011 - Site combined with 3.6. Minimal new erosion. 2013 - New erosion observed at bank toe. Trees on site now have exposed roots. 2015: No observed changes. [2015 Site ID: FHR_3-8_L]

USACE 2013 Photo #1

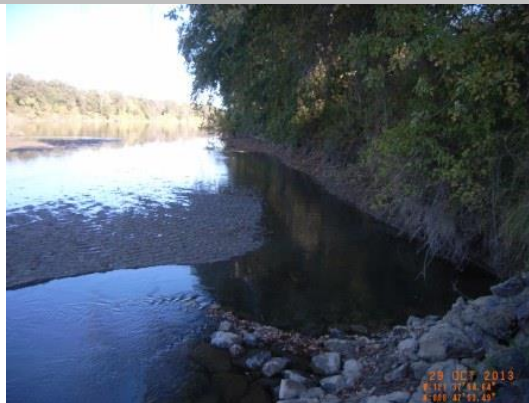
Photo 1 of 1 : SP\_2018\_RD1001\_38\_6\_20180302\_00006.jpg

LM Start	11.18	Rating **	M	Issue No.	6
LM End	11.37	Issue Type +	Ma	Location *	WS
Category	Supplemental			GPS Latitude/Longitude	
				Start	End
Item	2015 USACE Erosion Survey, DRAFT			38.800920 °	38.798165 °
				-121.633050 °	-121.631939 °
DWR ID	DWR_RD1001_04_s _ 2016_6				
Comment Code					
Inspector Comment					
2000 - Site is relatively stable except for some toe erosion at the upstream end, recommend monitoring the upstream end. 2004 - Some new block failures (10ft deep) at the toe of the upstream end. 2007 - Some minor new slumping at the waterline. 2013 - Minor new erosion along the bank toe. 2015: No observed changes. [2015 Site ID: FHR_1-0_L]

USACE 2013 Photo #1

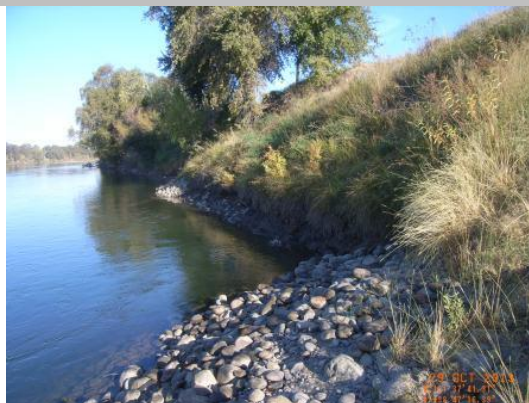
Photo 1 of 1 : SP\_2018\_RD1001\_38\_1\_20180302\_00001.jpg

LM Start	11.59	Rating **	M	Issue No.	1
LM End	11.75	Issue Type +	Ma	Location *	WS
Category	Supplemental			GPS Latitude/Longitude	
				Start	End
Item	2015 USACE Erosion Survey, DRAFT			38.795455 °	38.793394 °
				-121.629903 °	-121.628156 °
DWR ID	DWR_RD1001_04_s_2016_1				
Comment Code					
Inspector Comment					
1997- Deposits over top of cobble on the upper slope. 2000 - Old cobble site in poor shape; some toe retreat, but little change; steep bank. 2010 - Site extended upstream due to new toe erosion. 2012 - Minor new erosion at toe, new slumping, animals holes and cracks observed. 2015: No observed changes. [2015 Site ID: FHR_0-6_L]

USACE 2013 Photo #1

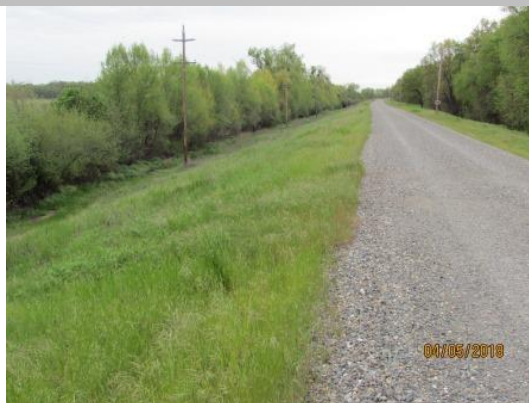
Photo 1 of 1 : SP\_2018\_RD1001\_39\_9\_20180411\_00025.jpg

LM Start	0.00	Rating **	M	Issue No.	9
LM End	5.38	Issue Type +	Ma	Location *	LS
Category	Earthen Levee			GPS Latitude/Longitude	
				Start	End
Item	Vegetation			38.781229 °	38.831007 °
				-121.605463 °	-121.529904 °
DWR ID	DWR_RD1001_05_f_2017_9				
Comment Code					
V1 : Control annual grass and weeds on the levee slopes and easements.					
Inspector Comment					
Annual vegetation has grown back too tall and needs to be maintained for visibility, Spring 2018.

View looking upstream landside of the annual vegetation that needs to be maintained for better visual inspection, Spring 2018.

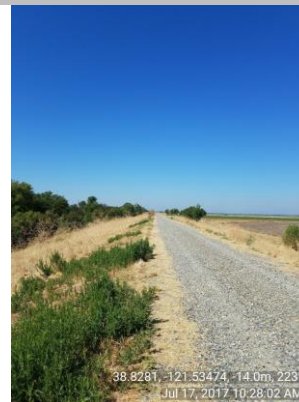
Photo 1 of 3 : LEVAL\_SP\_2018\_493\_1759.jpg

LM Start	5.05	Rating **	A/W	Issue No.	8	
LM End	5.06	Issue Type +	Ma	Location *		
Category	Supplemental			GPS Latitude/Longitude		
				Start	End	
Item	2017 Storm Damage			38.828100 °	38.828188 °	
				-121.534740 °	-121.534625 °	
DWR ID	DWR_RD1001_05_f_2017_8					
Comment Code						
Inspector Comment						
Levee Evaluation Comments						
Description:						
Site ID No:493						
Site Designation:RD 1001-03						
Repair Type: Erosion						
Rating:Serious						
Field Date:7/17/2017						
Notes: Serious per senior review

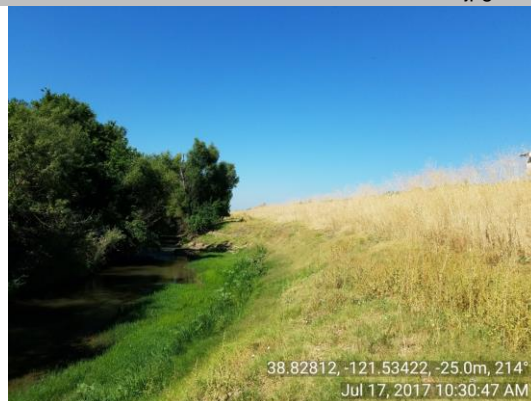
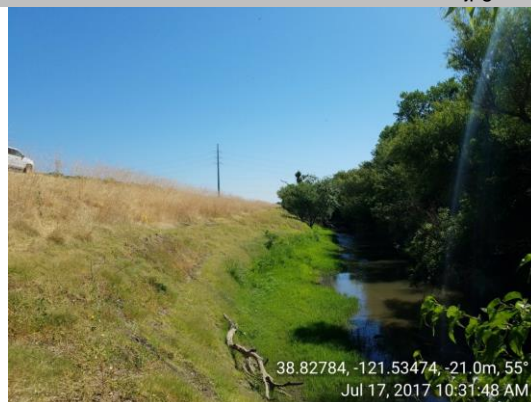
LM Start	5.05	Rating **	A/W	Issue No.	8 (cont)	
LM End	5.06	Issue Type +	Ma	Location *		
Category	Supplemental			GPS Latitude/Longitude		
				Start	End	
Item	2017 Storm Damage			38.828100°	38.828188°	
				-121.534740°	-121.534625°	
DWR ID	DWR_RD1001_05_f_2017_8					
Comment Code						
Inspector Comment						
Levee Evaluation Comments						
Description:						
Site ID No:493						
Site Designation:RD 1001-03						
Repair Type: Erosion						
Rating:Serious						
Field Date:7/17/2017						
Notes: Serious per senior review

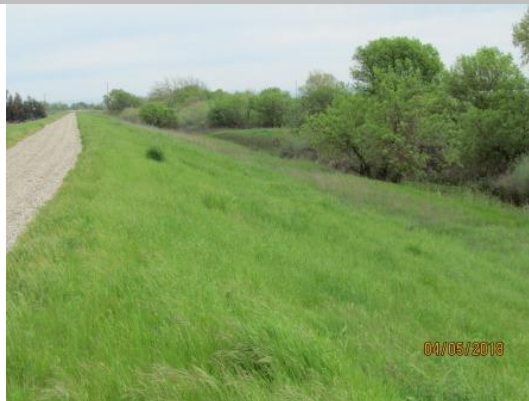
Photo 1 of 1 : SP\_2018\_RD1001\_40\_16\_20180411\_00040.jpg

LM Start	0.00	Rating **	M	Issue No.	16
LM End	4.73	Issue Type +	Ma	Location *	WS
Category	Earthen Levee			GPS Latitude/Longitude	
				Start	End
Item	Vegetation			38.831074 °	38.896360 °
				-121.529742 °	-121.520353 °
DWR ID	DWR_RD1001_06_f_2017_16				
Comment Code					
V1 : Control annual grass and weeds on the levee slopes and easements.					
Inspector Comment					
Annual vegetation has grown back too tall and needs to be maintained for visibility, Spring 2018.

View looking upstream waterside of the annual vegetation that needs to be maintained for better visual inspection, Spring 2018.

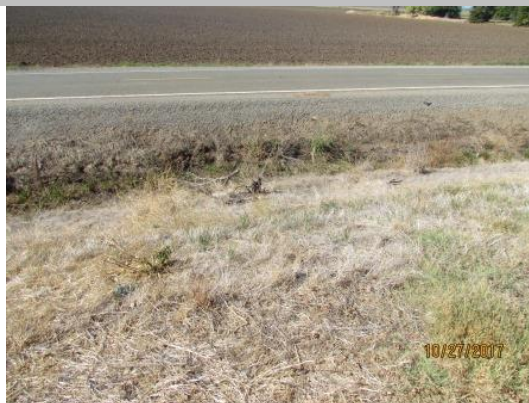
Photo 1 of 1 : SP\_2018\_RD1001\_40\_22\_20180302\_00011.jpg

LM Start	4.38	Rating **	N	Issue No.	22
LM End	4.38	Issue Type +	Ma	Location *	LS
Category	Earthen Levee			GPS Latitude/Longitude	
				Start	End
Item	Trim / Thin Trees			38.893728 °	38.893728 °
				-121.524715 °	-121.524715 °
DWR ID	DWR_RD1001_06_f_2016_22				
Comment Code					
T5 : Tree stumps.					
Inspector Comment					
A stump at the landside levee toe needs to be removed, Fall 2017.

View of a stump at the landside levee toe. Fall 2017.

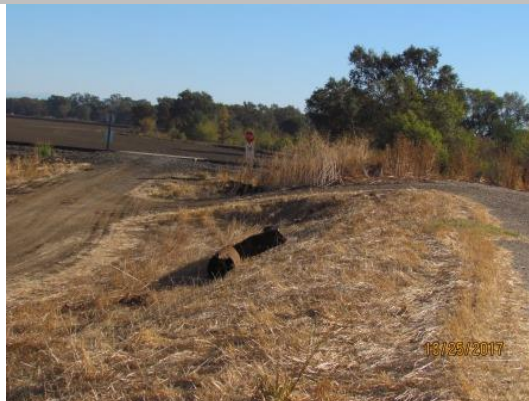
Photo 1 of 2 : SP\_2018\_RD1001\_40\_24\_20180302\_00012.jpg

LM Start	4.71	Rating **	M	Issue No.	24
LM End	4.71	Issue Type +	Ma	Location *	
Category	Earthen Levee			GPS Latitude/Longitude	
				Start	End
Item	Encroachments			38.896310 °	38.896310 °
				-121.520674 °	-121.520674 °
DWR ID	DWR_RD1001_06_f_2016_24				
Comment Code					
DE : Debris					
Inspector Comment					
Old peace of pipe lying on landside levee slope.

View of an old piece of pipe lying on landside levee slope looking upstream. Fall 2017.
